Tedori River Bridge repair

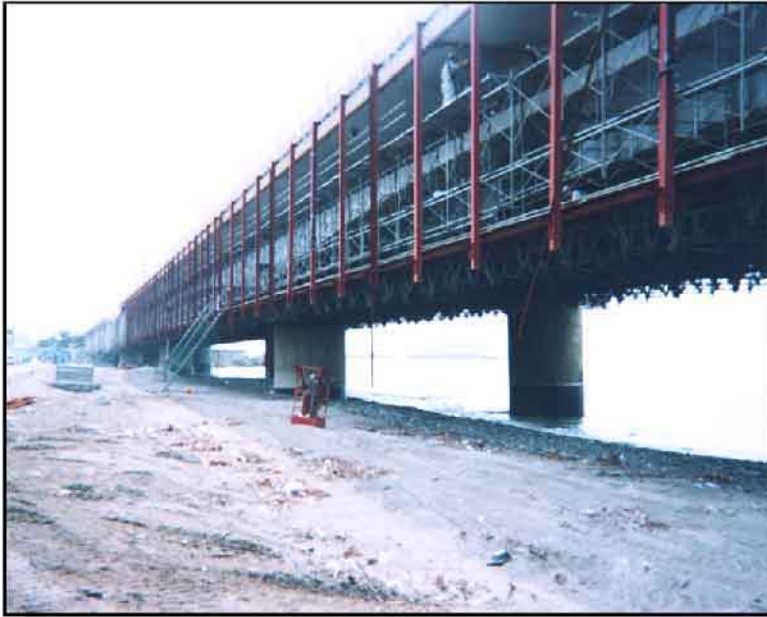
The outer web surface of the box girders and the lower surface of the bridge deck had to be repaired due to the damage caused by the infiltration of air-borne salt. Initially, a water jet was used to scarify the surfaces. NEFMAC was attached by anchor bolts, and then a polymer mortar was injected.
